Modification of the TOS sensor (Tip Over Sensor) in GV650 and GT650

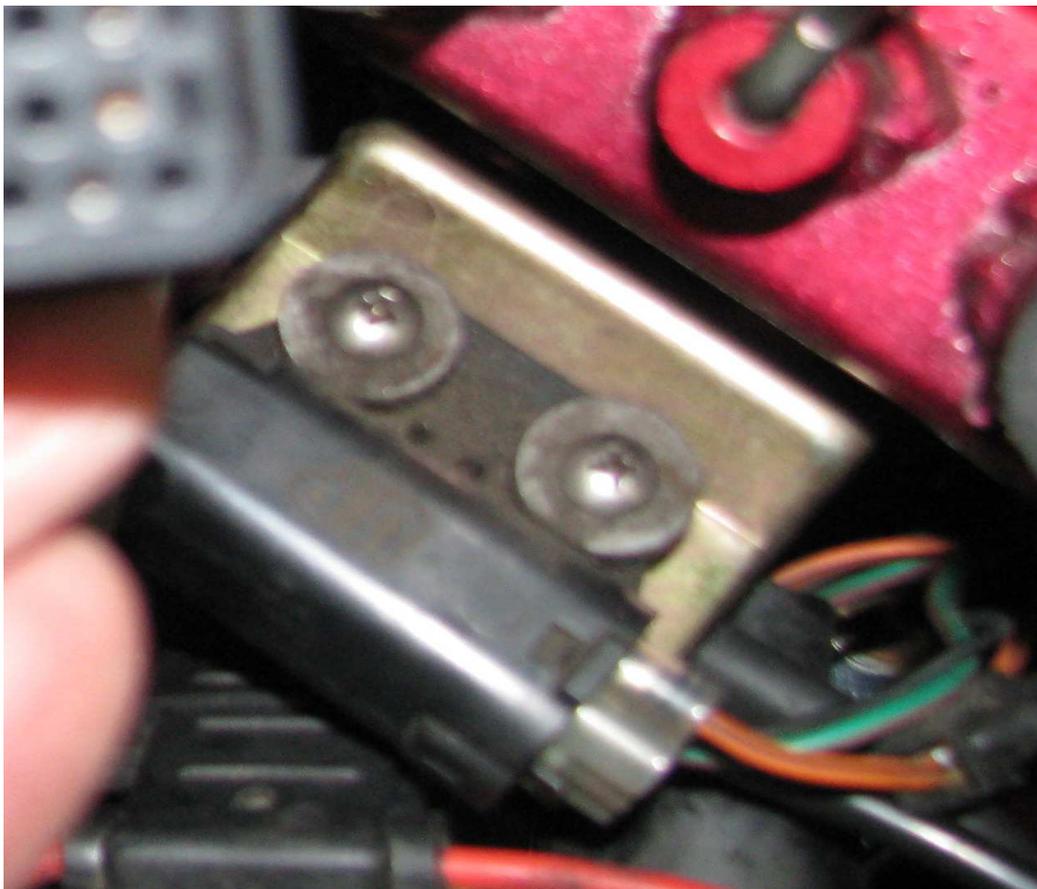
View of the sensor in a motorcycle

The GV650's Tip Over Sensor is mounted under the seat and is bolted to the fuel tank mounting plate where it is mounted to the frame. Two Phillips screws are used to mount the sensor to the plate. Once you remove the screws, unplug the cables and remove the sensor from the motorcycle.

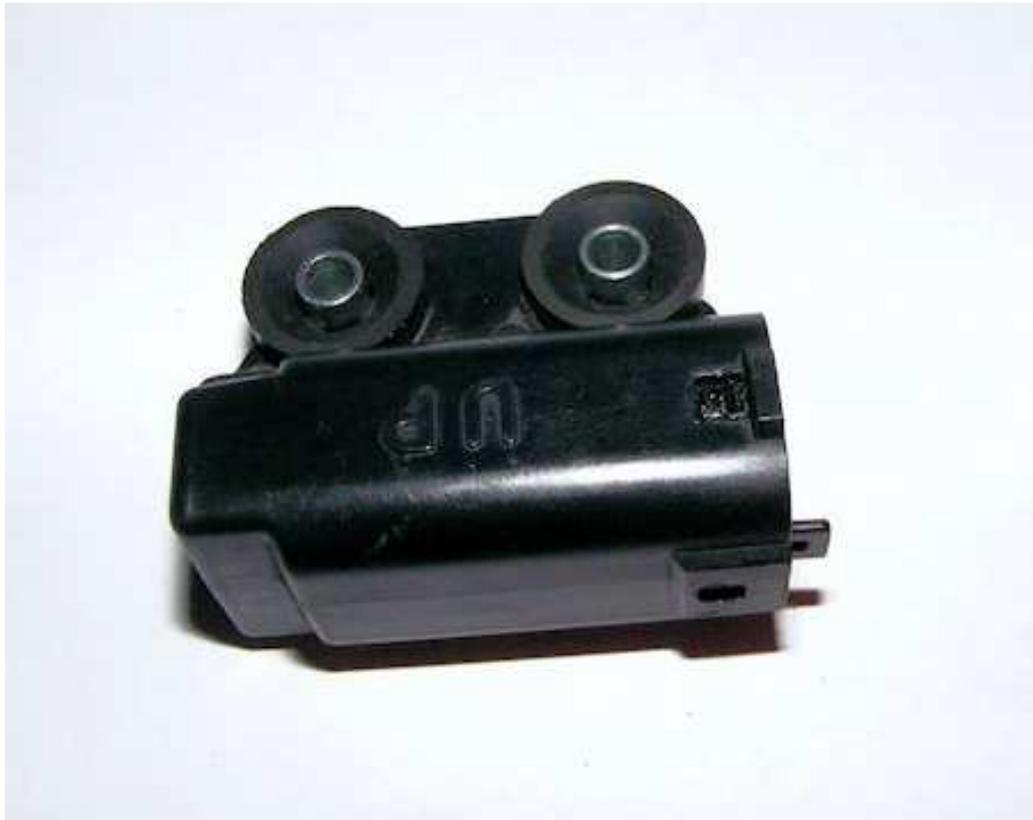
View of disassembled sensor

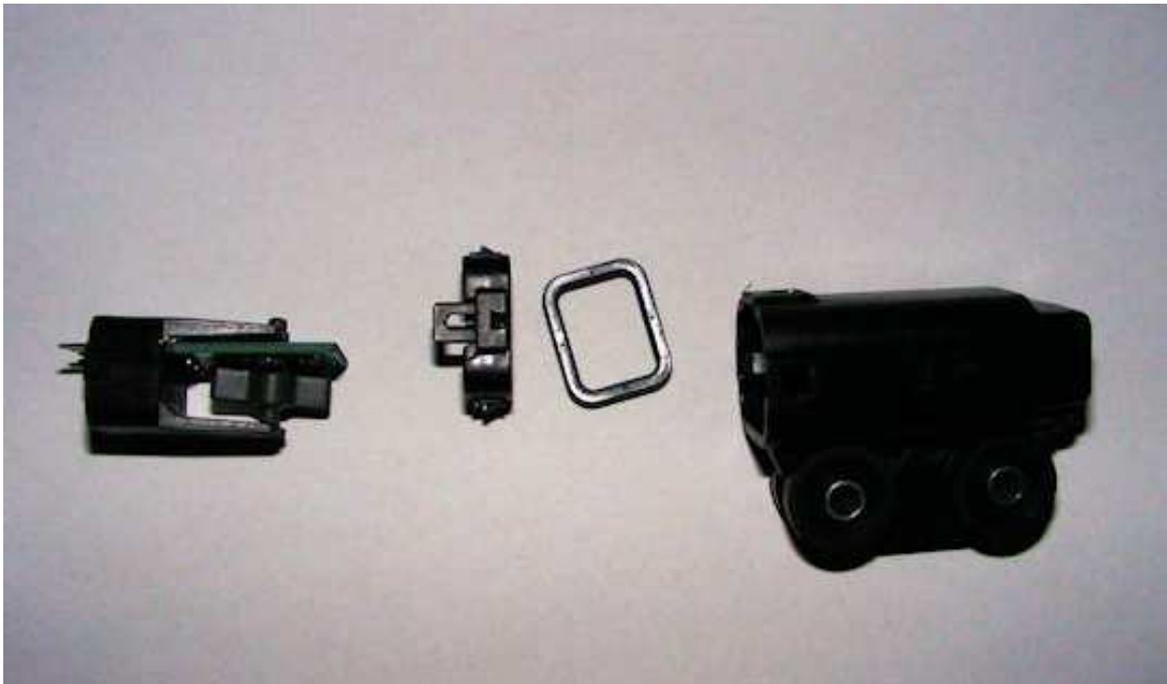
View of the individual sensor parts

Just use a small flat edge screwdriver to pry the sensor apart.

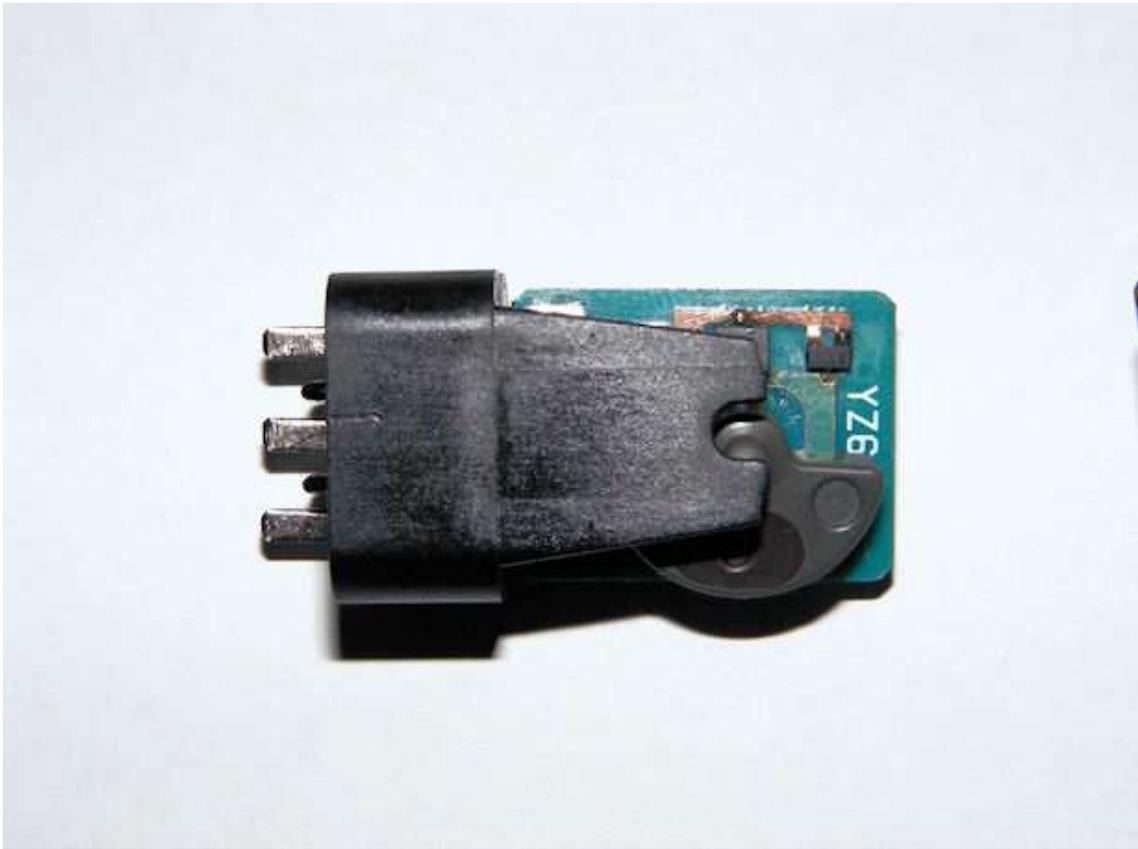
Close-up of the sensor out of the cover

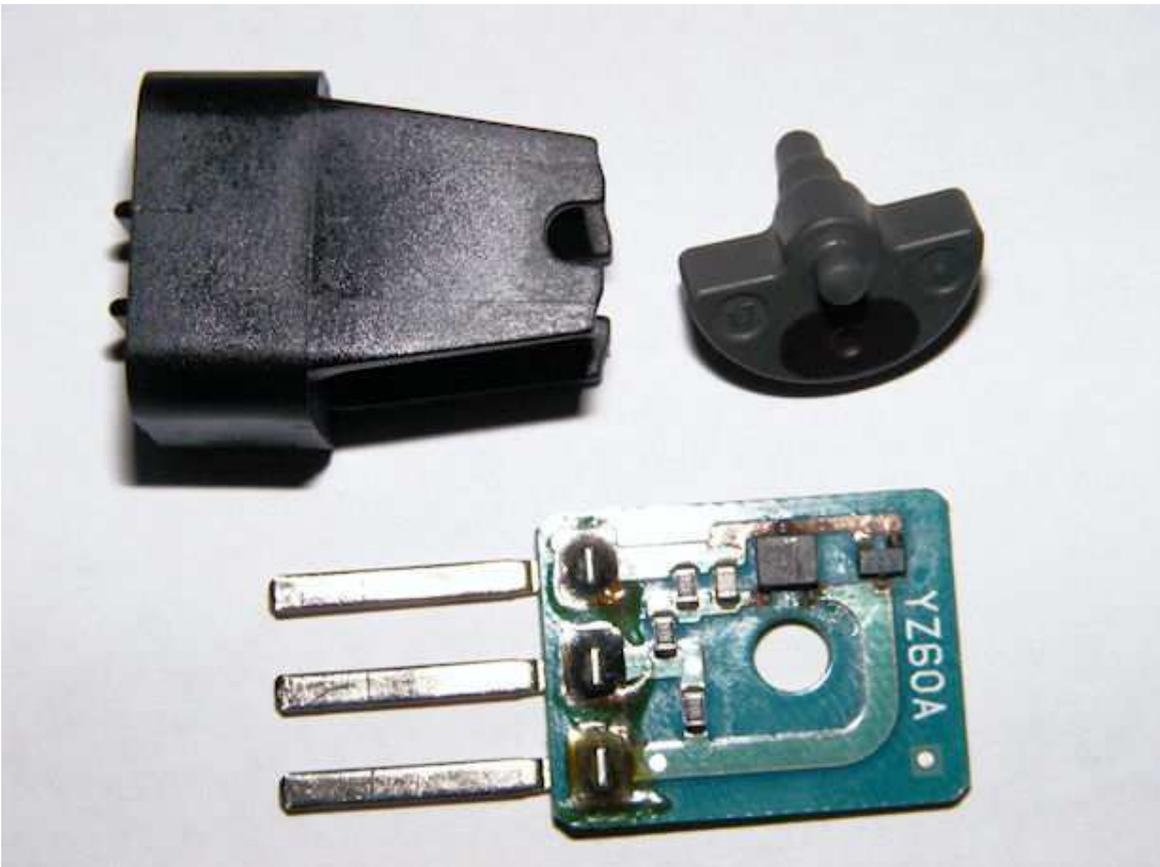
View of the board after removing the sensor

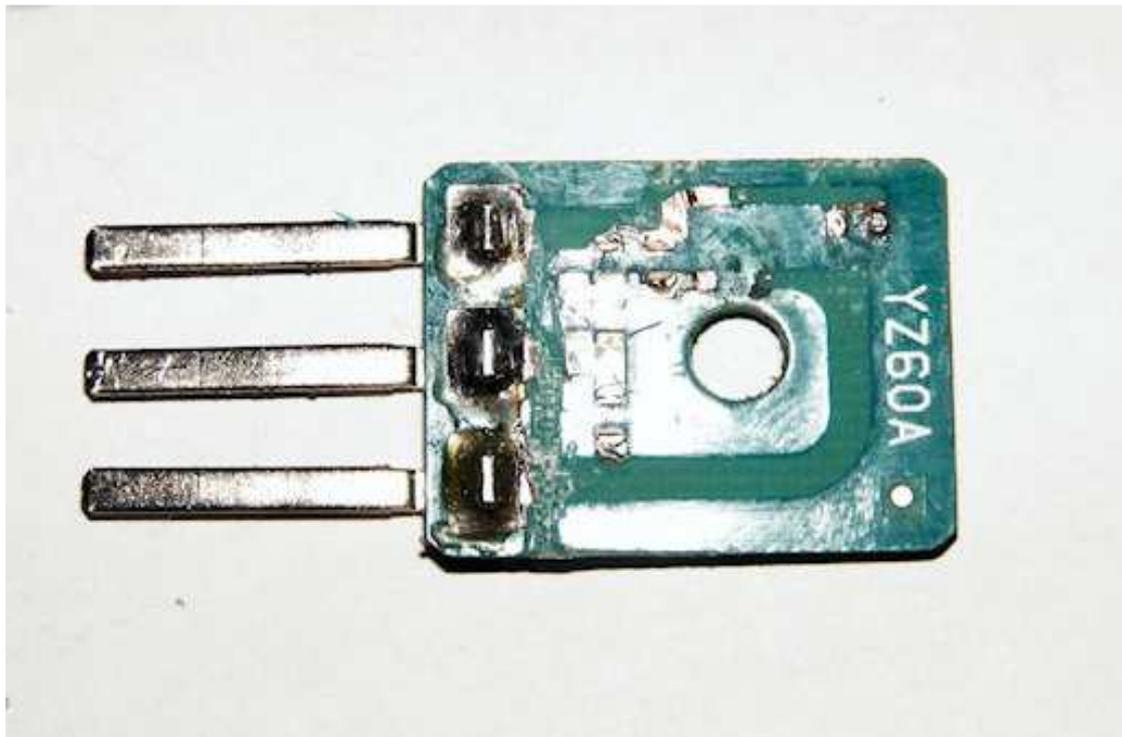
View of the sensor plate after removing all elements

The next step is to cut all the tracks on the sensor plate and remove all electronic components. You may want to use a soldering iron or a sharp knife.

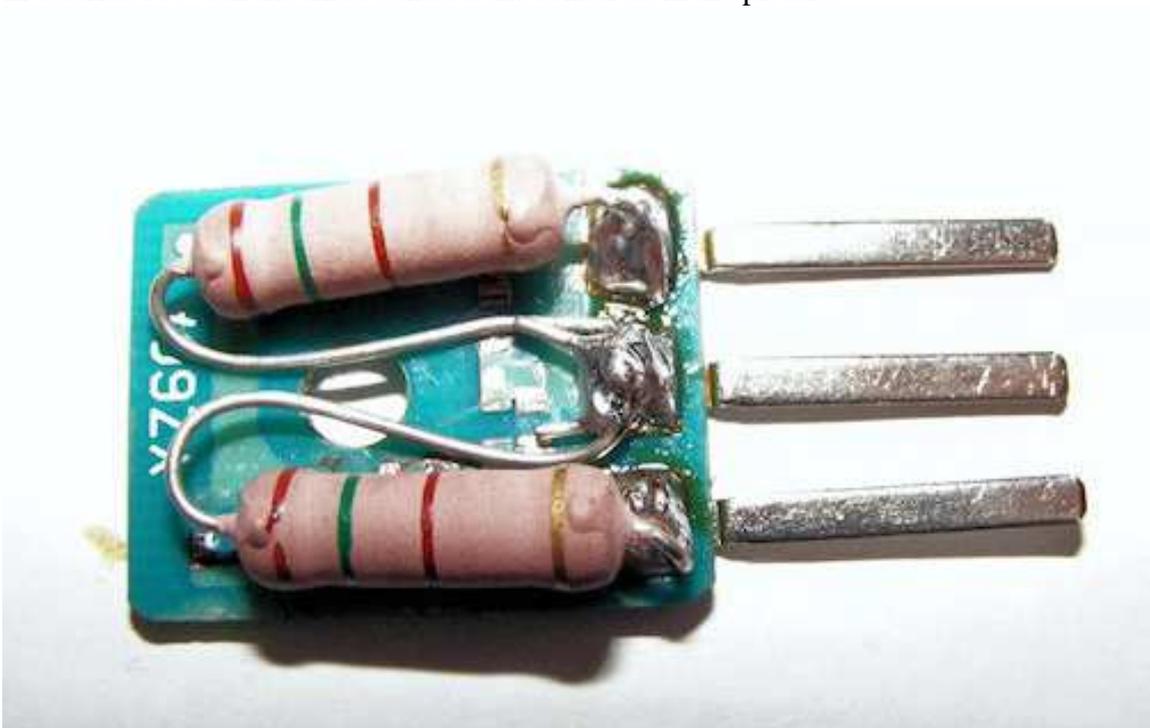
View of resistors soldered to the contact sensor

The next step of the modification is to solder two resistors (150 Ω , 3 W) to the board. We solder the resistors in a series between the three contacts the sensor as in the picture.

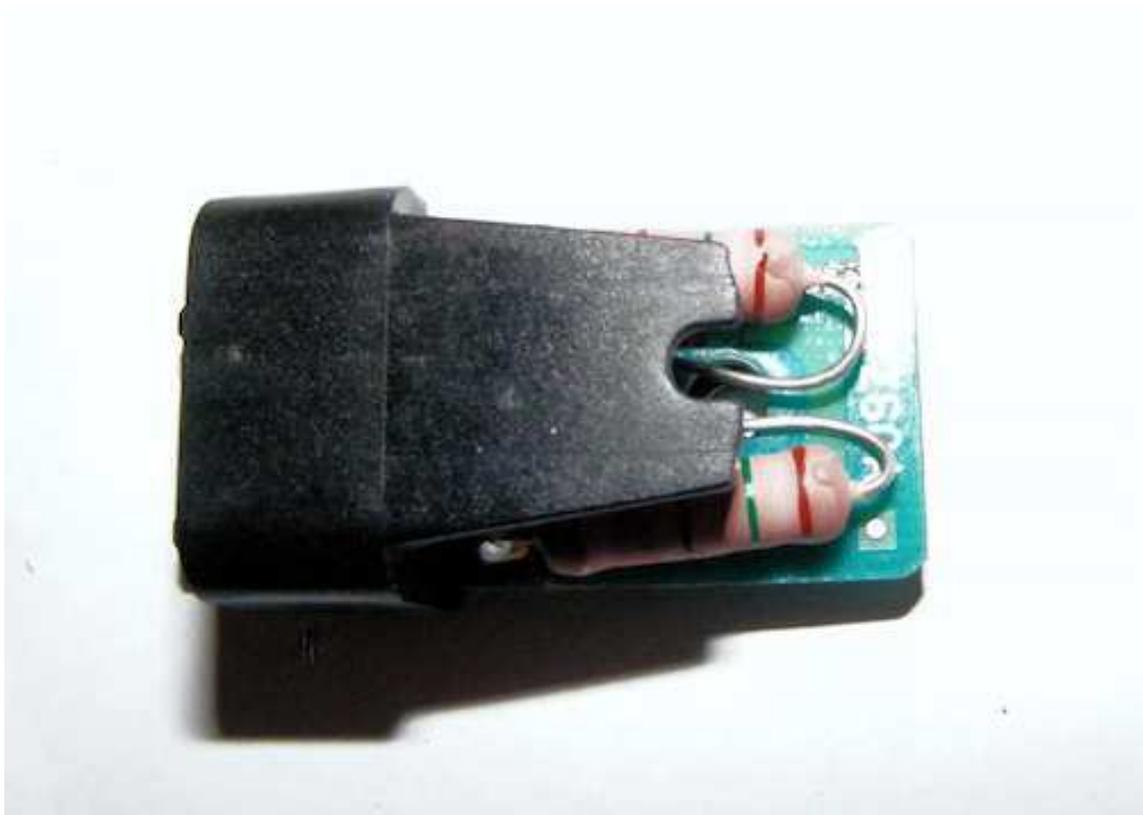
View of the modified sensor when placed in the cover

Once the resistors are soldered in place the tray back in the cover.

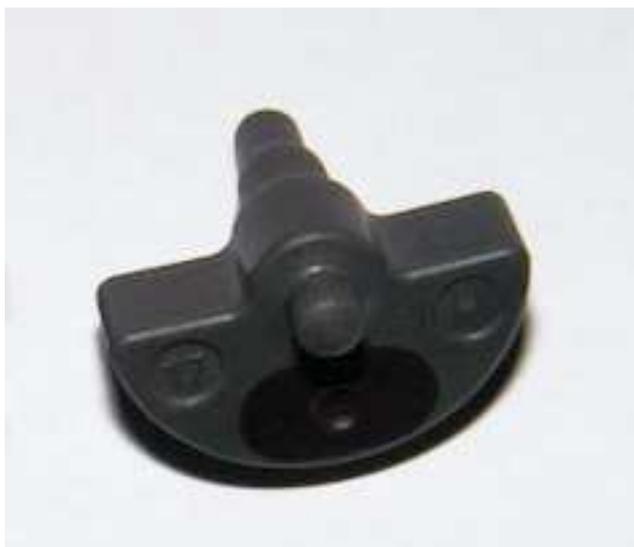
Please note that this modification does not use the back magnetic element that mounted on the axle in the hole of the plate.

Unnecessary element

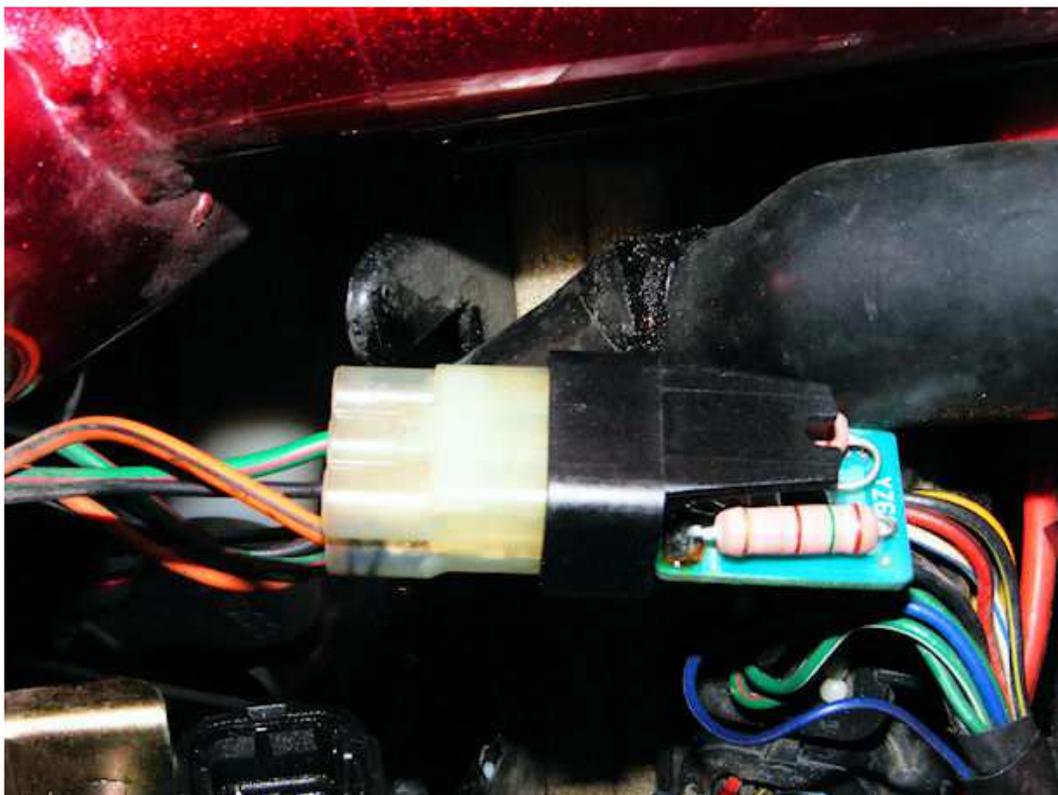
Placing the sensor after modification

The modified sensor can be placed anywhere on a motorcycle. The only limitation is the length of the wires connecting the sensor.
