Manual removal of AIS with GV 650 FI and GT 650 FI

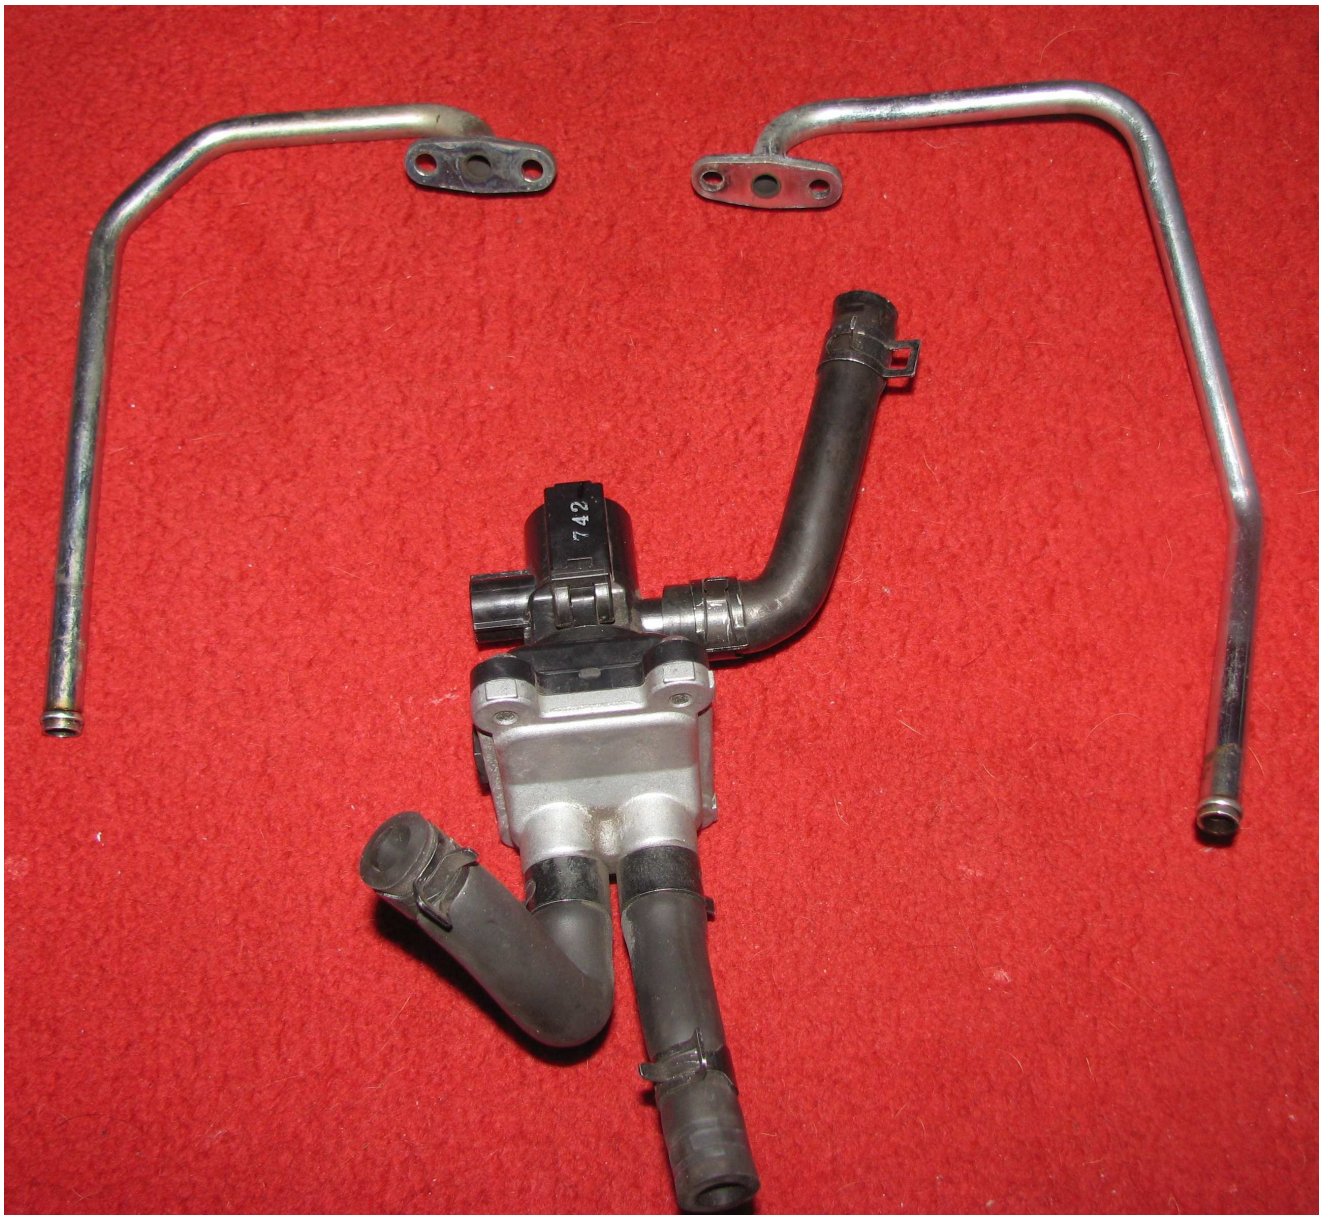
View of the dismantled parts - air pump and two pipes from the cylinders.

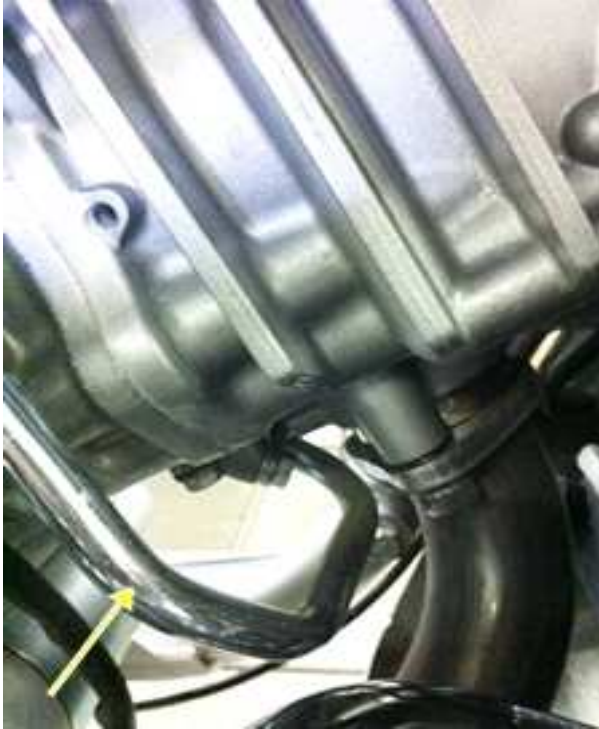
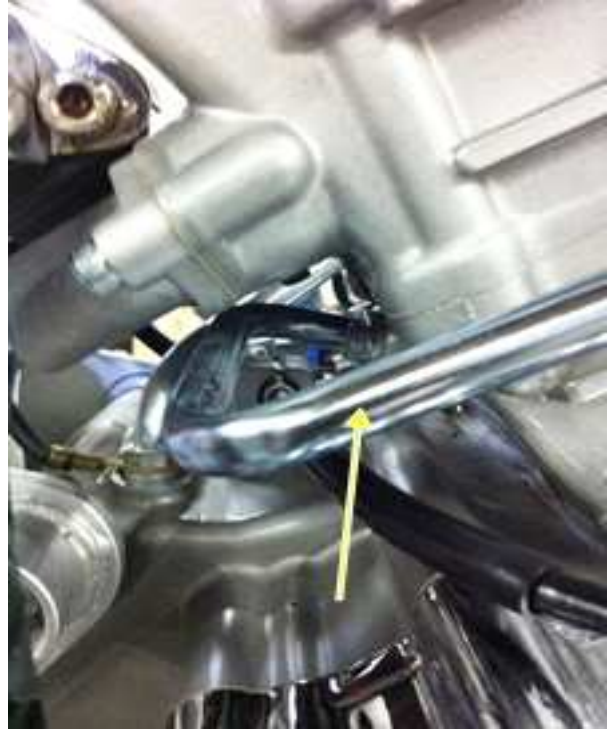
The arrangement of the AIS - the tube around the front and rear of the cylinder to be removed.

The factory bolts are screwed M6 hexagon with the ability to use a Phillips screwdriver. Screws are not too hard, so I recommend using a wrench to the 10 dimension.

Biggest problem is removing the bolts securing the tube to the cylinder block. In the case of the front cylinder simply unscrew the radiator, and then go into the motorcycle and remove the two screws. In the case of the rear cylinder, the situation is more complicated because of poor access. Screw on the right side, you can dial without much problem, I used a fairly short spanner M10. On the other hand removing the bolts, is a challenge. We must show great patience, that at approximately ¼ turn twist the screw, which is about 30 mm. Here are just a short wrench will help us. If I did it today, then I turned the exhaust manifold from the rear cylinder, because as it turned out, screwing the bolt is even harder. After removing the screws, gently pull the tube from the cylinder mount and try to save the factory pad. In my case, pad, the one on the front cylinder was glued (baked into the socket and I had to gently use a knife). In the case of the rear cylinder pad that was loose and fell out yourself by removing the two screws.

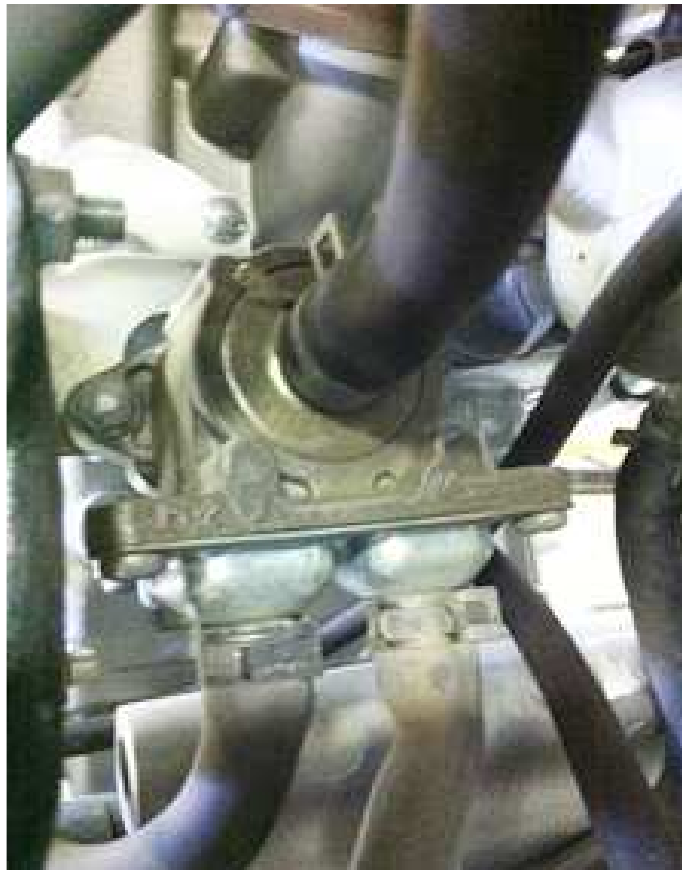
View of the air pump with cables - two lower steel tubes going to the cylinders and the upper to the airbox.

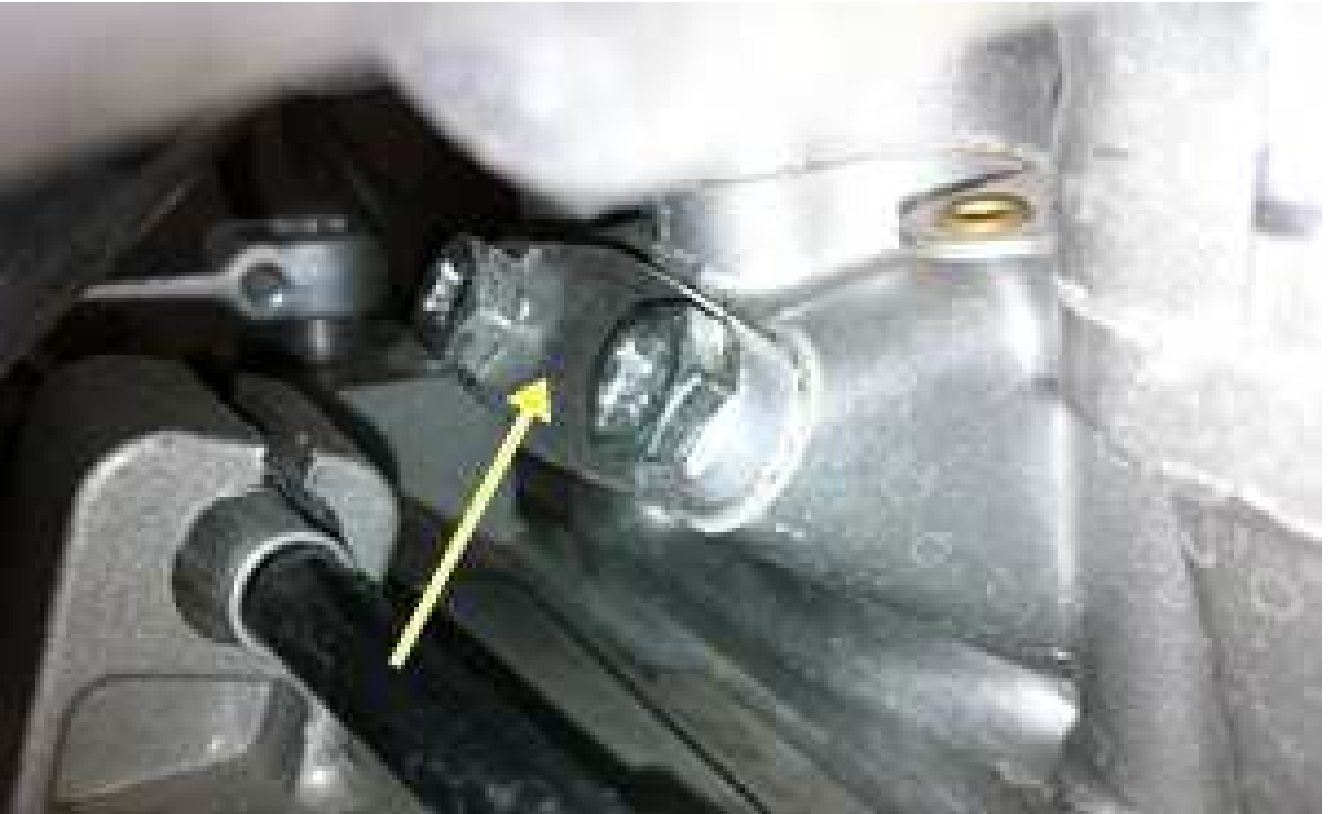
AIS slot sealed rear cylinder (viewed from the right) after removal of the tube blinds aluminum profile with a washer on the two screws.

Knowing the quality of the screws I decided to use the factory screws holding the same length, that were I to remove the factory exhaust. They are made of much better quality steel, plus I was hoping for a stronger tightening them. I do not want to while driving either of the screws come loose causing a leak to the cylinder. Traditionally, assembly plugs on the front cylinder is a fabulously simple, while the rear cylinder is a problem. If someone like me will not be dismantled exhaust manifold, you must first pre-tighten the screw on the right side, as pictured below. Then, after arming themselves with patience we take up the left side. I am also opting for the allen screws hindered the task. Spanner easier still operate in these conditions. After about an hour of work totally into the rear bolt and I could deal with blindness airbox.

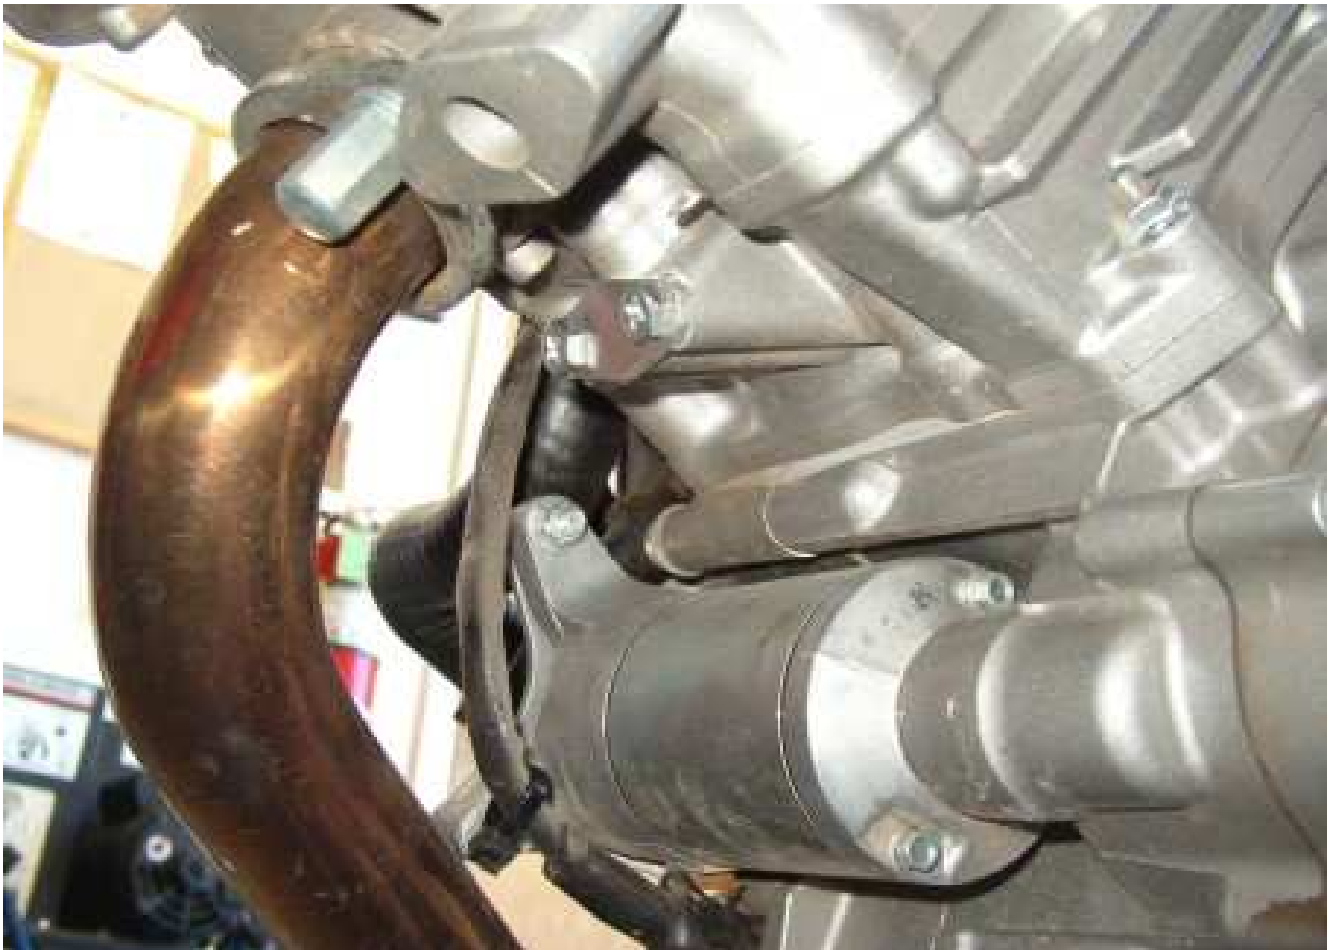
View blocked the AIS on the front cylinder (the view from the left)

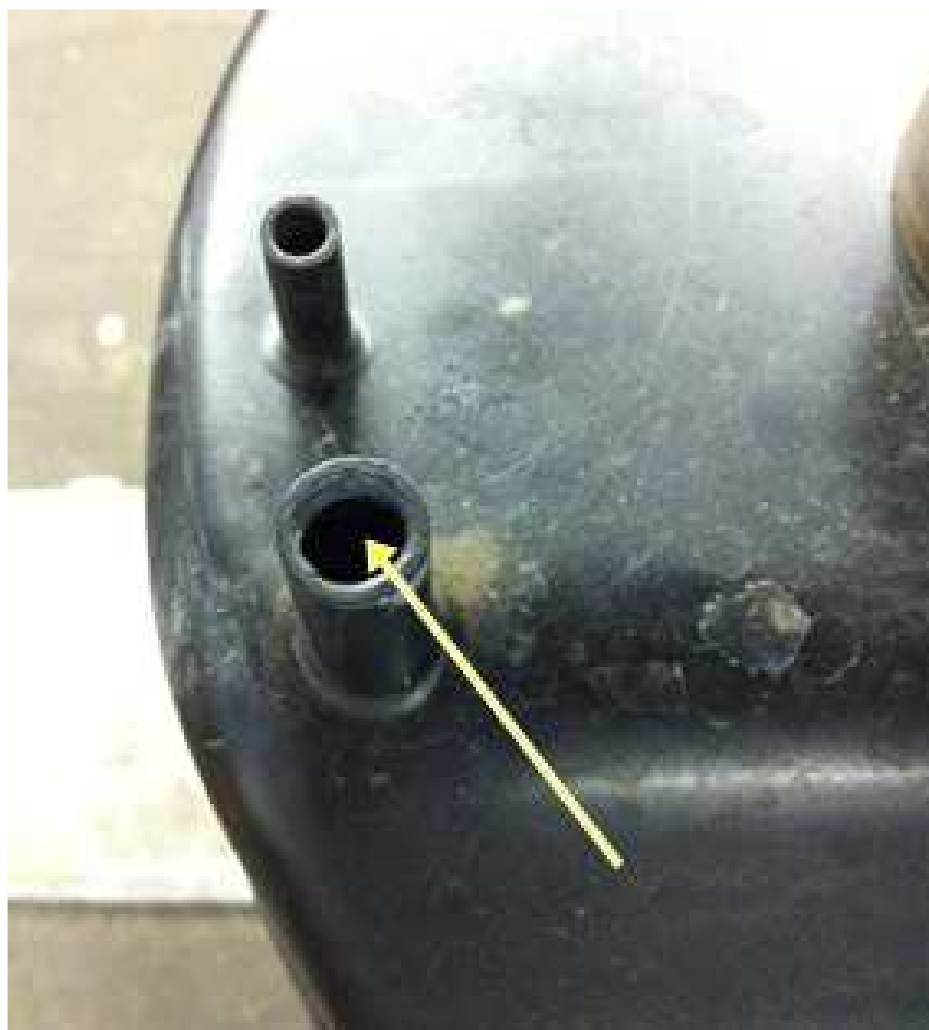
View the airboxie stub. Please note that in our case the air filter is removed a few such connections.

Hole in airbox decided to protect in terms of leakage and mechanical vibration of the whole cabinet. To this end, I used quite a long bolt with a diameter of 8 mm and 60 mm long. Before inserting it covered the entire length of the silicone, and countered from the bottom nut.
